UNITED STATES DISTRICT COURT  
SOUTHERN DISTRICT OF NEW YORK

-----X  
:  
:  
IN RE M/V MSC FLAMINIA : 12-cv-8892 (KBF)  
:  
:  
:  
-----X  
:  
:

KATHERINE B. FORREST, District Judge:

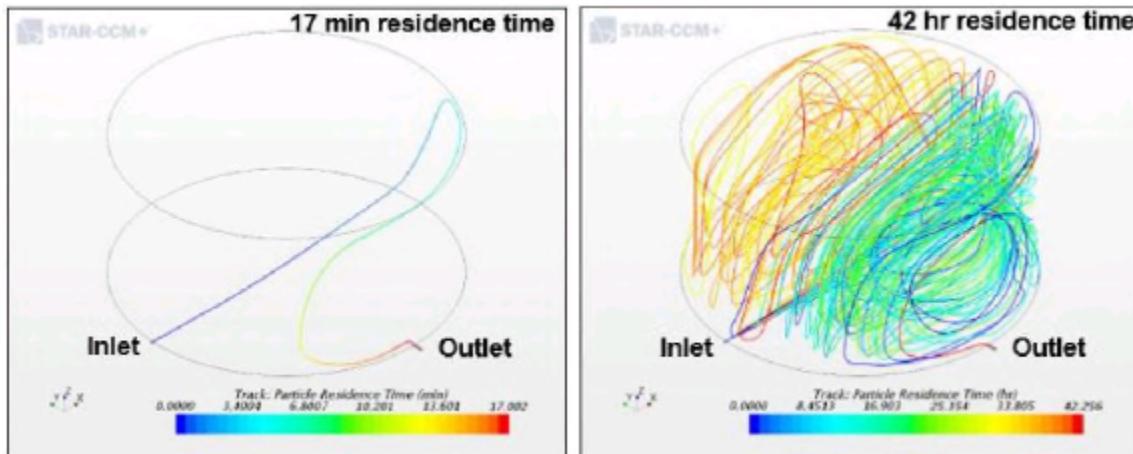
Figure 2.

(Id. at 40–41, ¶ 119.) Figure 2 depicts the path and residence time of massless tracer particles.<sup>18</sup> (Id.) The left diagram depicts the path of the tracer particle that stayed in the tank for the shortest amount of time, 17 minutes; the right diagram depicts that path of the tracer particle that stayed inside the tank for the longest amount of time, 42 hours. From this experiment, Dr. Davis concluded that particles in the MV-804 tank completely mix from top-to-bottom in the tank and that there is no evidence of stagnant layering (that is, no DVB80 liquid remaining in one place without mixing with TBC and oxygen). The mixing ensured that there were near homogenous oxygen levels at all layers (that is, heights within the tank), and that DVB80 was also periodically rising to the surface and mixing with air. (Id. at 41, ¶¶ 120–123.)

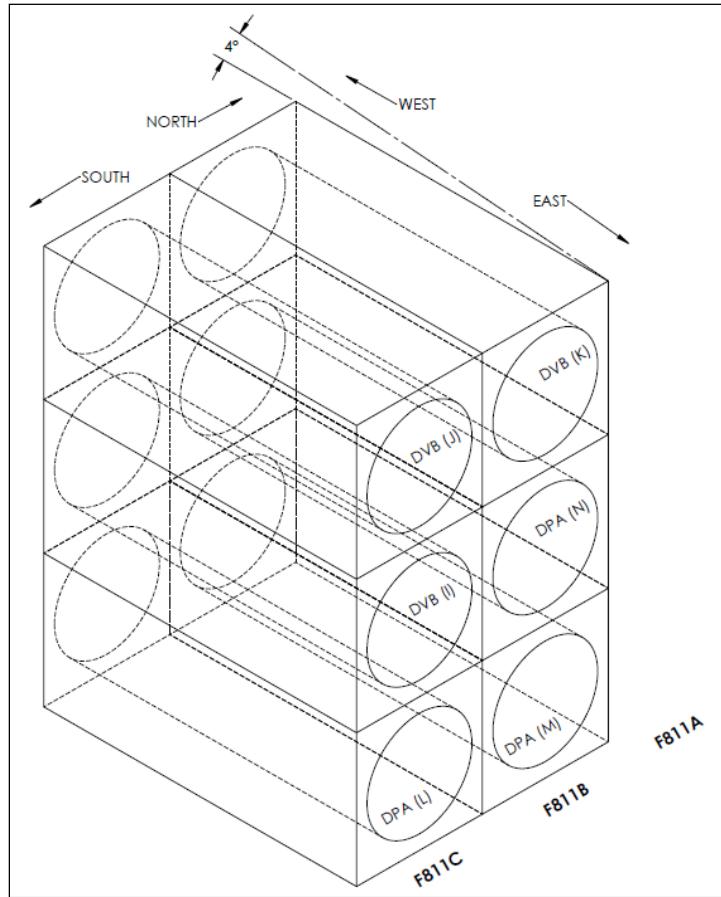
Figure 4.

Third, at NOT, the DVB80 containers were adjacent to containers of heated DPA and other cargo. The following diagram shows the arrangement of the DVB80 containers (Tanks I, J, and K) and the relevant DPA containers (Tanks L, M, and N):

(Davis Decl. at 17, ¶ 9.) As evidenced from the diagram, while on the dock at NOT, Tank I was exposed to thermal radiation from three neighboring ISO containers filled with heated DPA: Tanks L, M, and N.

The conditions in which the ISO container in the Willbros Study was placed did not approximate those at NOT or aboard the Flaminia. First, and most significantly, the ISO container was never placed out in the open, where solar radiation would directly hit a portion of the container, and the container would be exposed to ambient temperatures that fluctuated into the 90s (Fahrenheit). Second, when in the warehouse, the container with DPA was not proximate to any other containers with heated DPA that might have emitted some heat. When both on the dock at NOT and in storage aboard the Flaminia, the ISO containers filled with DPA were proximate to one another. For instance, DPA (N) was directly below DVB (K), and directly adjacent to DVB (I). DVB (I) was also directly above another container with DPA, DPA (L). DPA (M) and DPA (N) were each diagonal from DVB (I) and (J), respectively. (See fig. 4.)

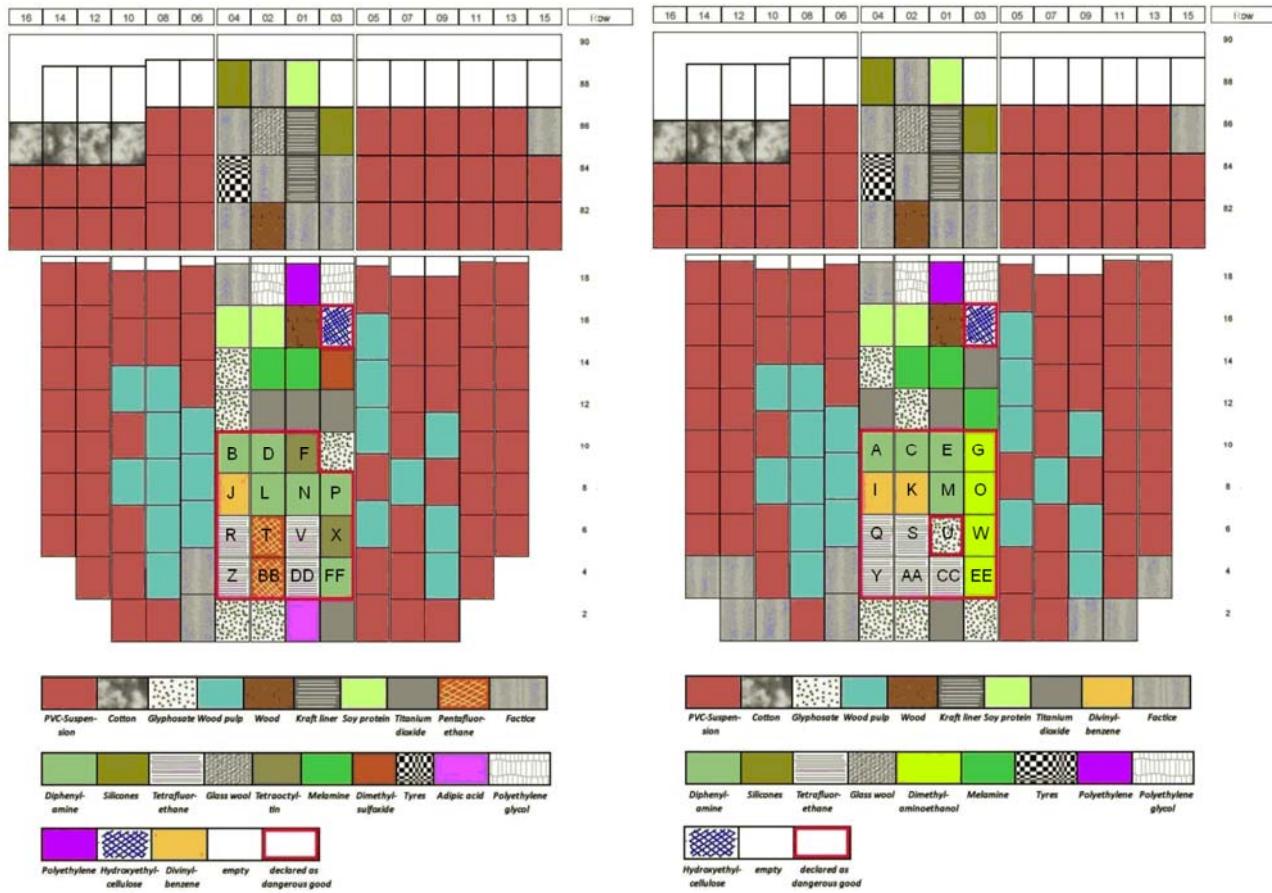
Figure 5.

(Id. at 22, ¶ 31.) This diagram shows that in Hold 4, Tank J was surrounded on two sides by Tanks B and L, and diagonal to Tank D, all of which contained DPA. Similarly, Tank A—of heated DPA—was stored directly on top of the least insulated portion of Tank I, and Tank C was diagonal to it; Tank K had top, side, and diagonal DPA containers.
